# **Kolomoki Mitigation Bank, Spring Creek Mitigation Area**

## **Fifth Year Wetland Monitoring Report**

**January 2014 through December 2014**

**USACE File Number 200410120**

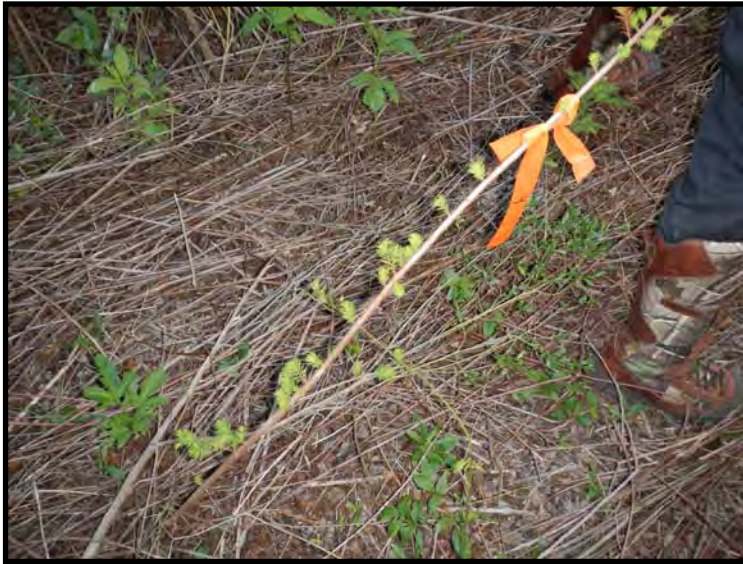
Cypress sapling damaged by vehicle driving through in MS-12. Tree was pushed onto the ground but was easily pulled back up and measured.

Three to twelve species were observed at each station. No one to two species is dominating an area with the exception of MS-5 (a tupelo-cypress system) and MS-12, an area impacted by field equipment. Tupelo is dominating the MS-5 area due to natural recruitment and MS-12 is dominated by swamp chestnut oak. MS-12 also lost tree diversity due to equipment damage.

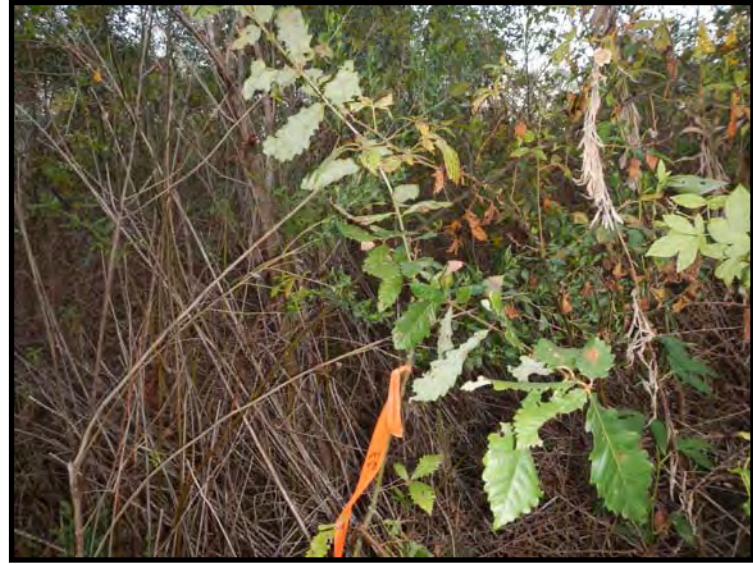
Swamp chestnut oak sapling within MS-12. Sapling was overcrowded but surviving/thriving.

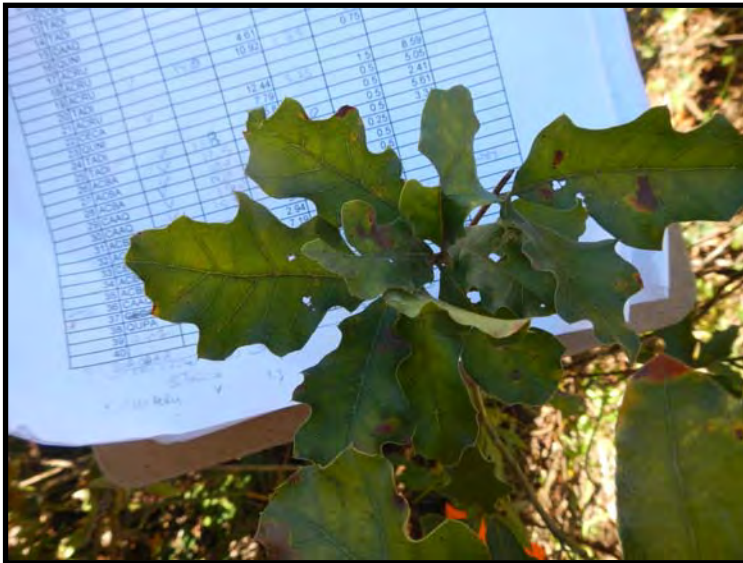
Insect damage to planted tree within MS-4.

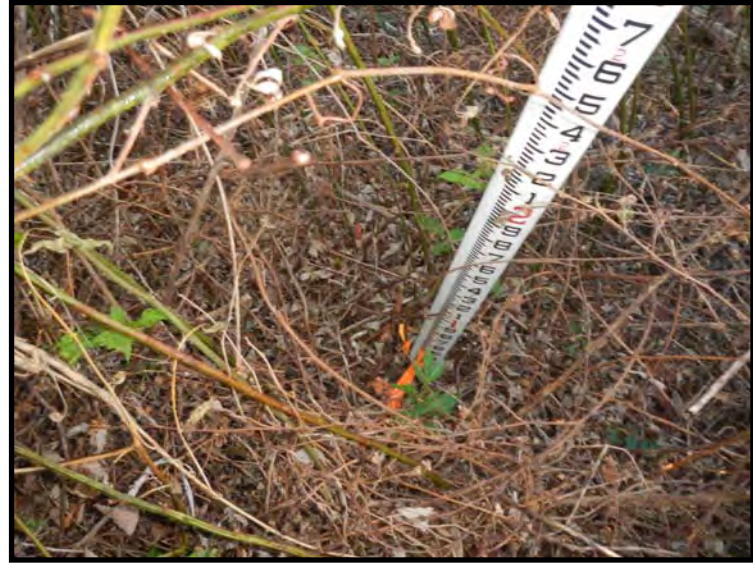
Bent cypress due to extensive overgrowth in MS-11. Overgrowth was clipped back.

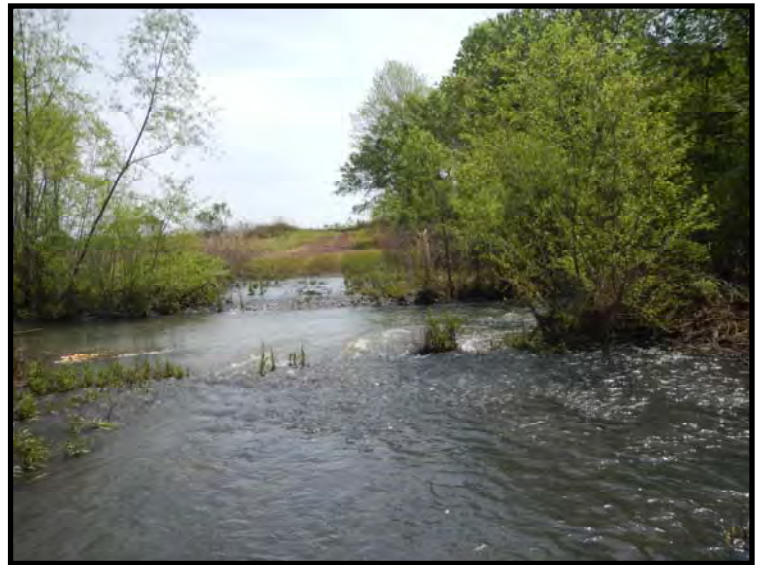
Flooding of roadway and adjacent wetlands at T3.

A site compliance inspection with the Interagency Review Team was conducted on March 11, 2014. During this visit, a beaver dam was observed near the location of the old dam in T3. Ponding of the adjacent wetlands and immediate stream section was observed in proximity to this beaver dam. The bank sponsor removed this dam in April 2014 and continues to perform regular inspections of the area to prevent further issues from arising.

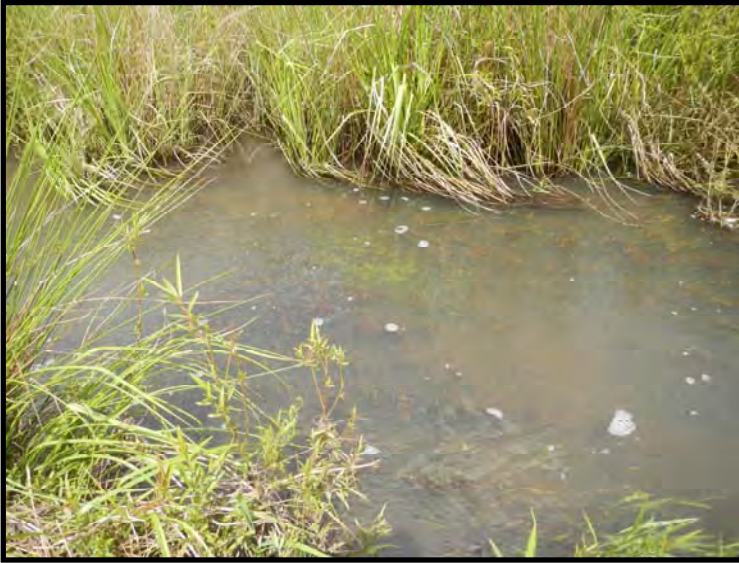
Macrophyte bed observed during macroinvertebrate collection.

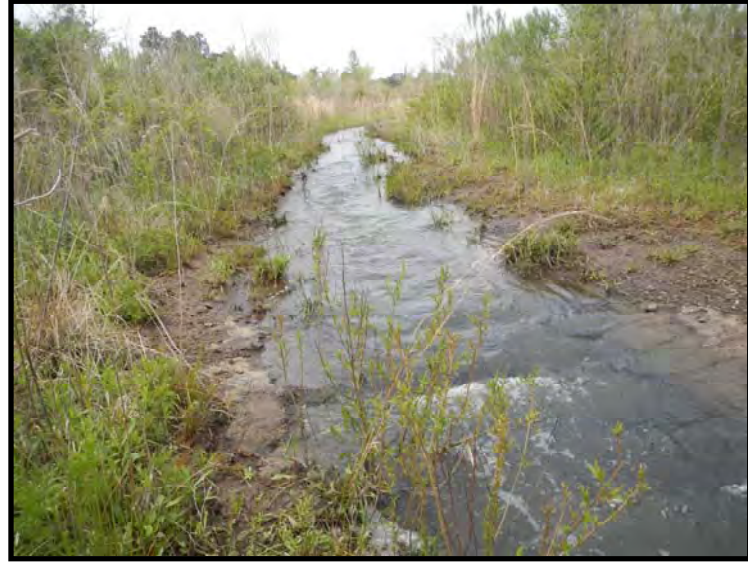
Overlooking step pool flow and bedrock substrate within T1.

Channel substrate within restored reaches ranged from bedrock to silt/clay particles. T1 had a composite dominated by sand, clay, and some gravel with minor bedrock; T2 was dominated by sand and clay particles (old point bars within bends had sand/gravel mix); and T3 was dominated by clay. Iron ore particles were significant throughout T1 and T2 and was classified as gravel during the pebble count. At times, clay would be in ball like structures (marble sized), but was still classified as clay/silt.

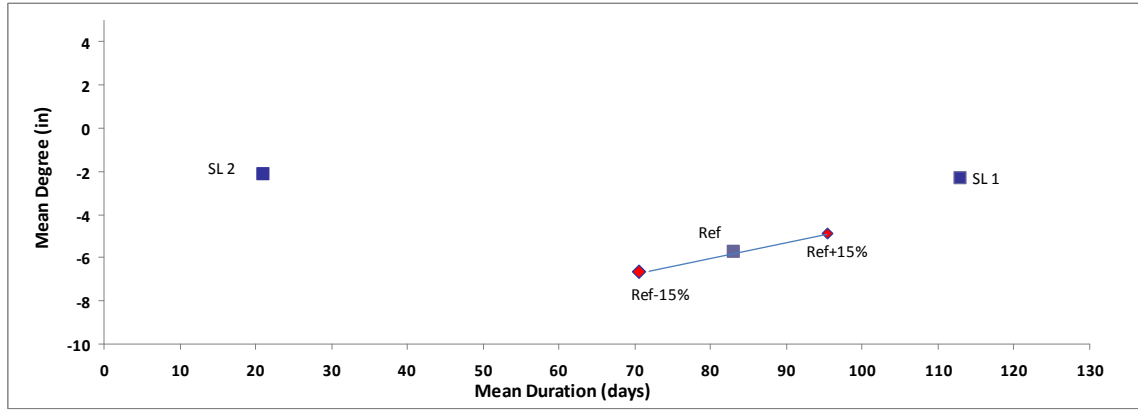
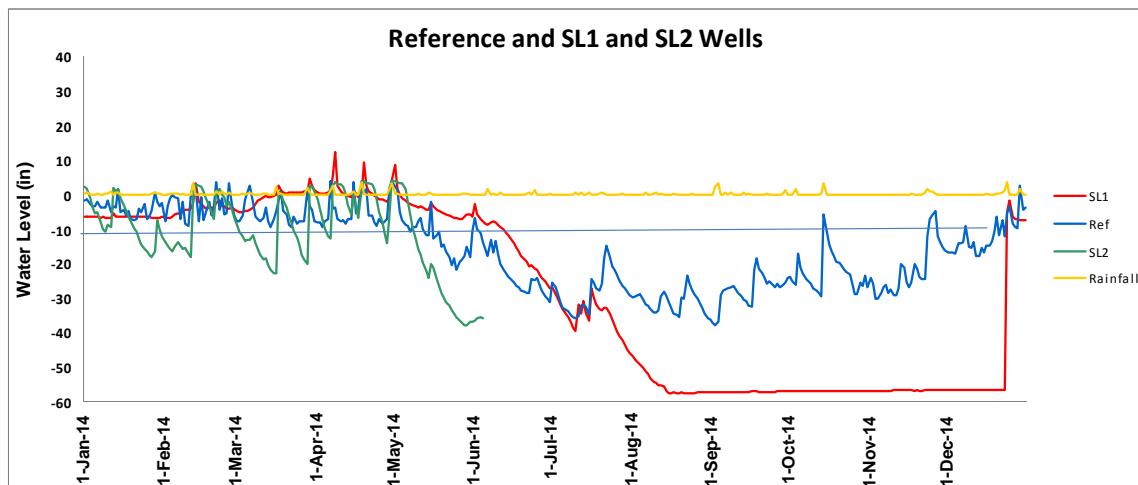
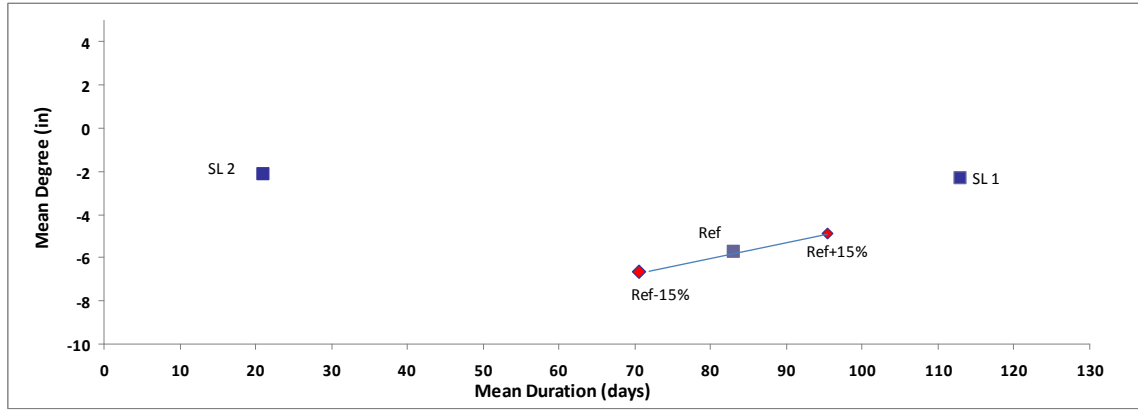
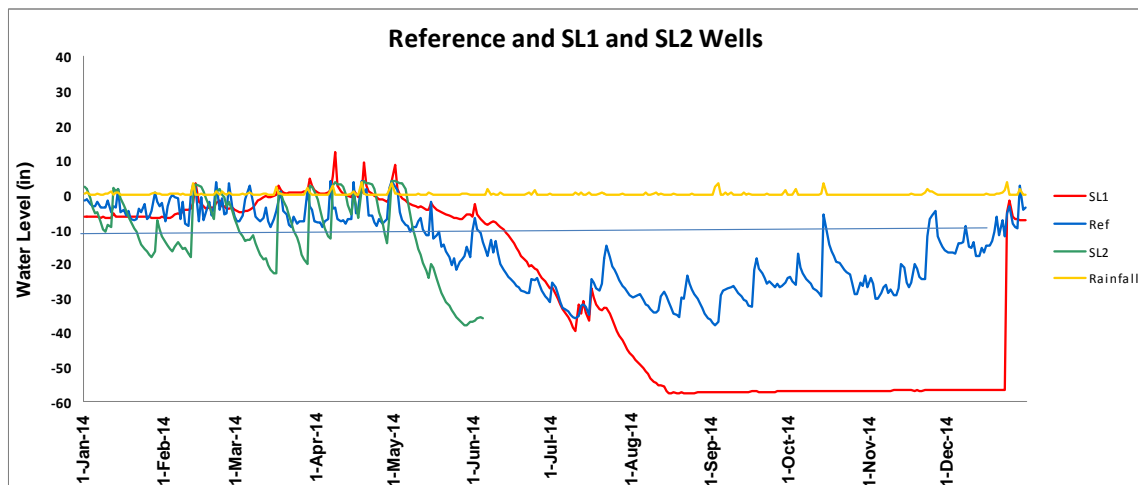
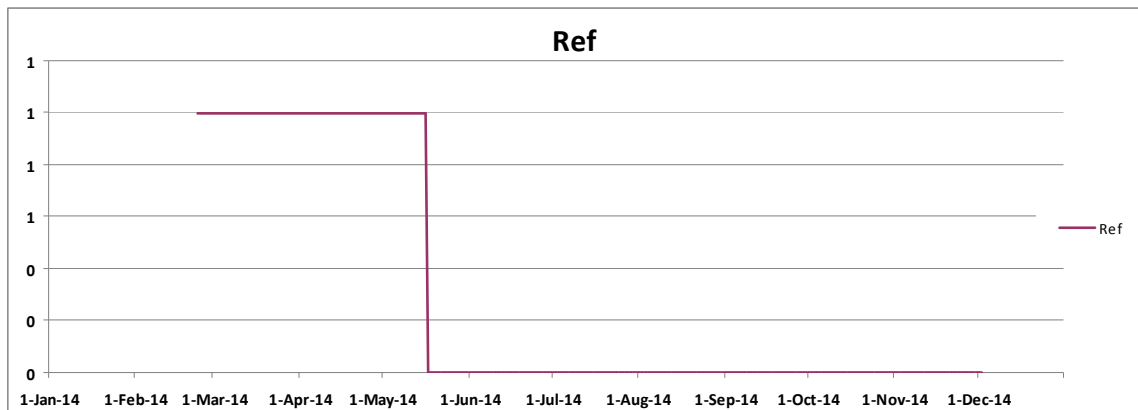
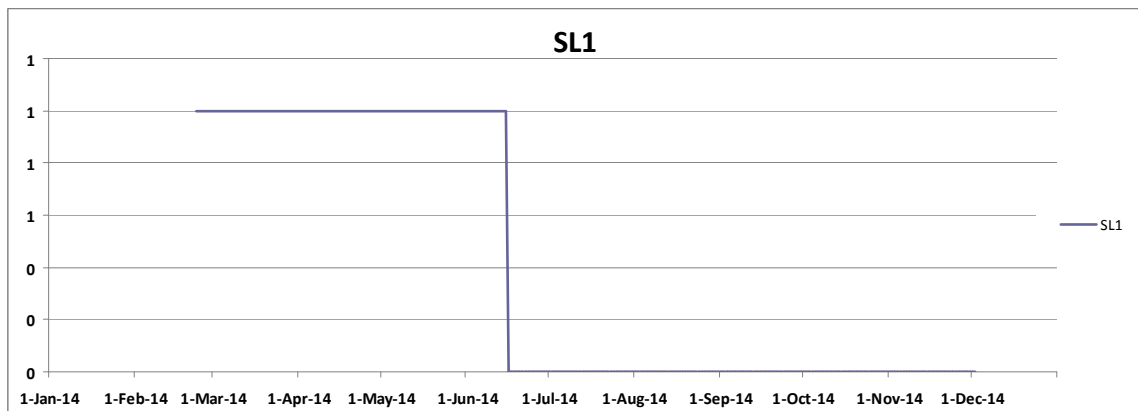
# Kolomoki-SCMA Well Data Year Five

Monitoring wells SL1 and SL2 were not within 15% range of degree and duration of the reference well DP1; however, all three had surface inundation or saturation of the upper 12 inches for at least 14 consecutive days during the growing season (February 23 through December 2), meeting the basic success requirement for hydrology. SL2 is trending closer (within 20%). SL1 malfunctioned between June and December 2014 and all data was lost for that timeframe (the well was sent back to the manufacturer to attempt to retrieve data; however, the well was too damaged. A new well was installed to record water levels for subsequent monitoring periods). Well data can be seen in Appendix D.

Well data indicates that the mitigation bank met basic hydrology success criteria of surface inundation or saturation within the upper 12 inches during the growing season and monitoring wells are within 15% of periodicity of reference well. Well SL2 is trending closer to the 15% range of degree and duration and is anticipated to reach the 15% success criteria by the end of Year 7. The SL1 data logger malfunctioned during Year 5 and no data was recorded from June to December 2014; a new data logger was installed.
